CASE STUDY

Wisconsin State
Highway 114

86-Year-Old Reinforced Concrete Pipe Reinstalled

Solutions: The service life of reinforced concrete pipe extended with the addition of two precast end walls

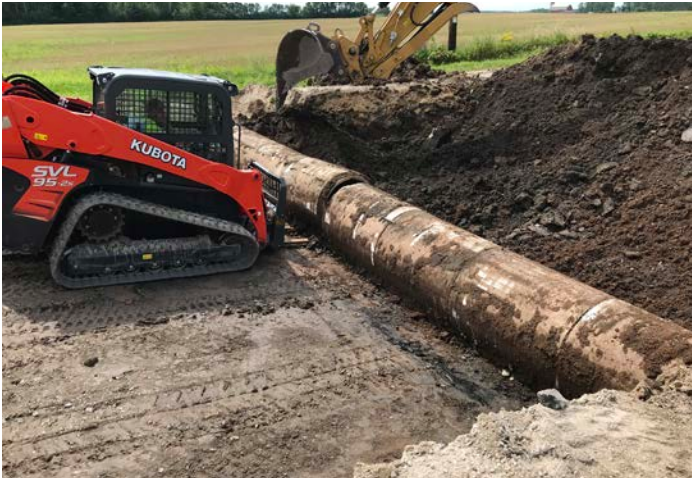
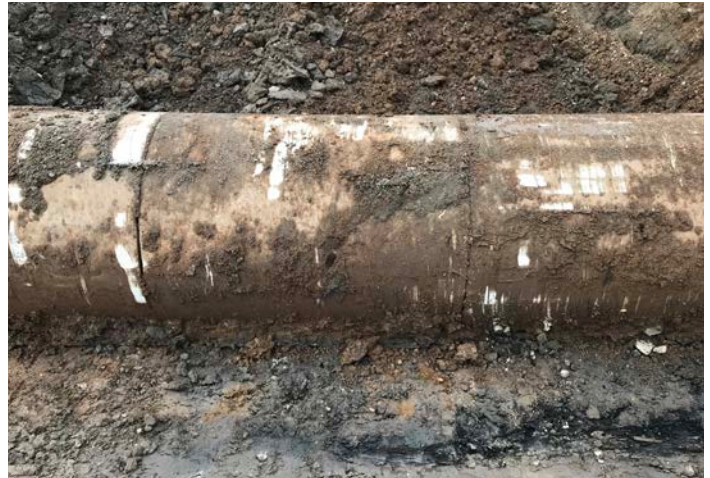
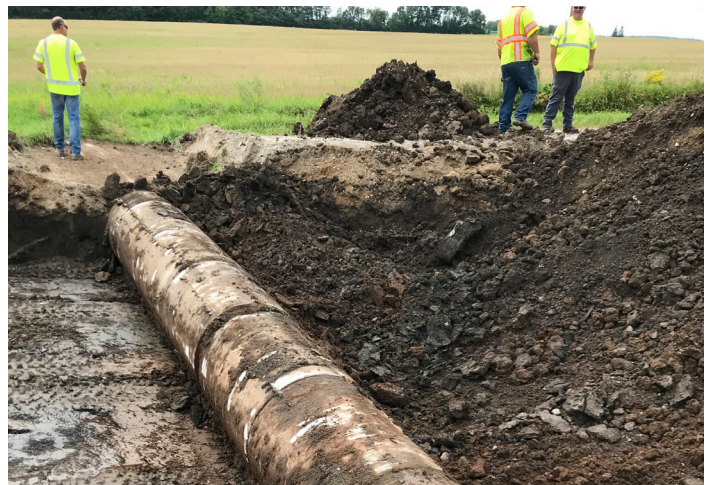
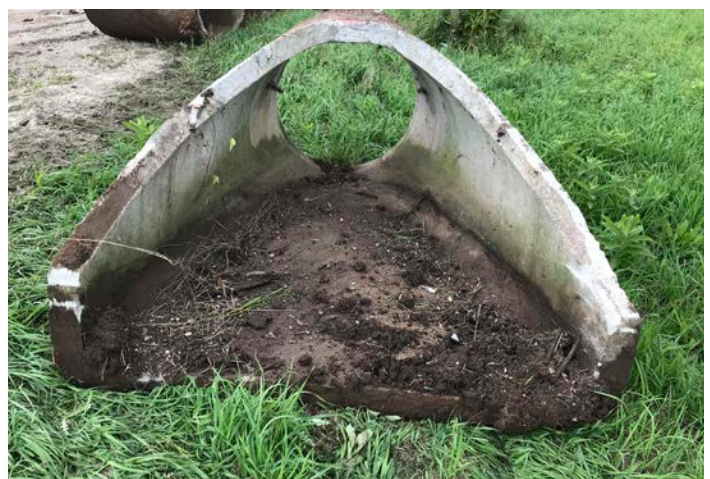
The project began by unearthing the existing concrete pipe. Crews exercised caution while removing the RCP, being careful not to disturb its end joints. Once above ground, the pipe was cleaned to look like new, and its joints were wrapped in filter fabric to prevent dirt from penetrating the drainage system. Once reinstalled, the end walls were set, concluding the two-day project.
